INDOOR AIR QUALITY ASSESSMENT

**Marshfield Town Hall
870 Moraine Street
Marshfield, Massachusetts**

Prepared by:
Massachusetts Department of Public Health
Bureau of Environmental Health
Indoor Air Quality Program
May 2017

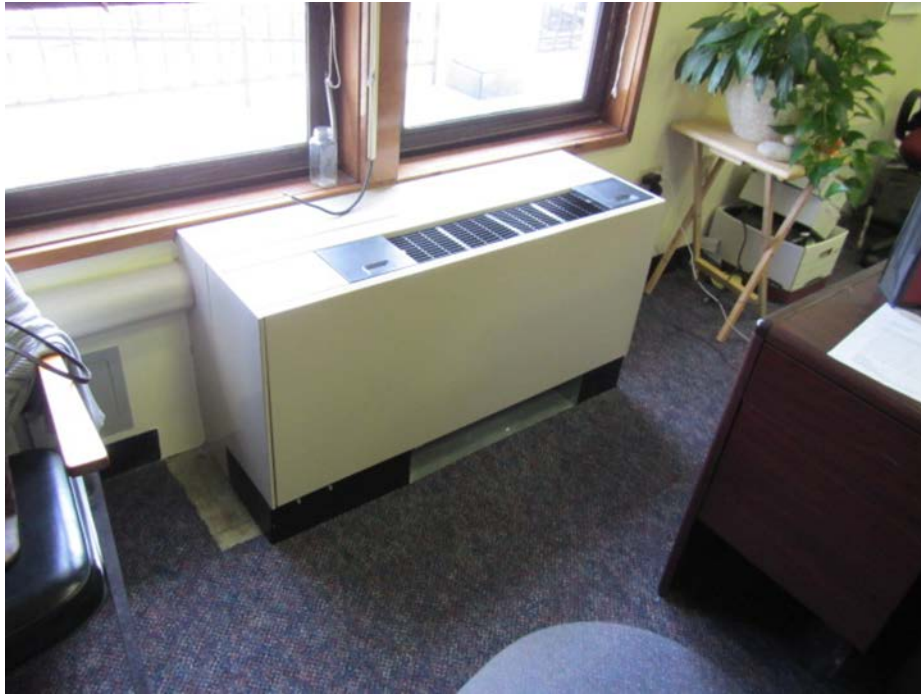
Picture 1

Mechanical ventilation in the areas tested is provided by fan coil units (FCUs; Picture 1). FCUs at the MTH draw air from the outdoors through a fresh air intake located on the exterior wall of the building (Picture 2) and returns air through an air intake located at the base of the unit. Fresh and return air are mixed, filtered, heated or cooled and provided to rooms through an air diffuser located in the top of the unit (Figure 1). In a few cases FCUs were obstructed on top as well as in front of the units (Pictures 3 and 4), which can impede airflow, effect temperature control and over a period of time, damage equipment.

Fan coil unit (FCU)

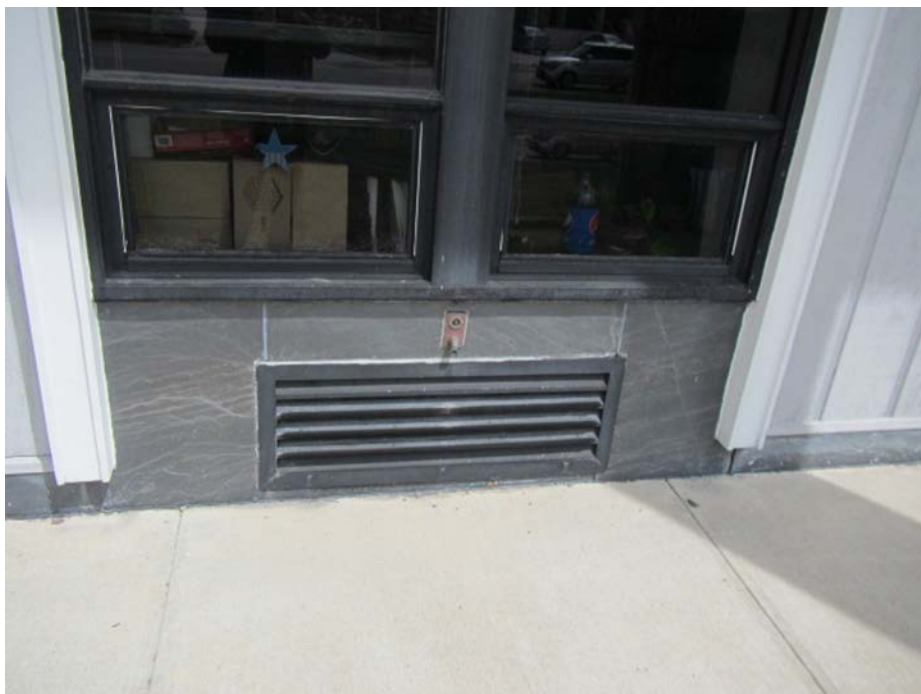
Picture 2

FCU air intake

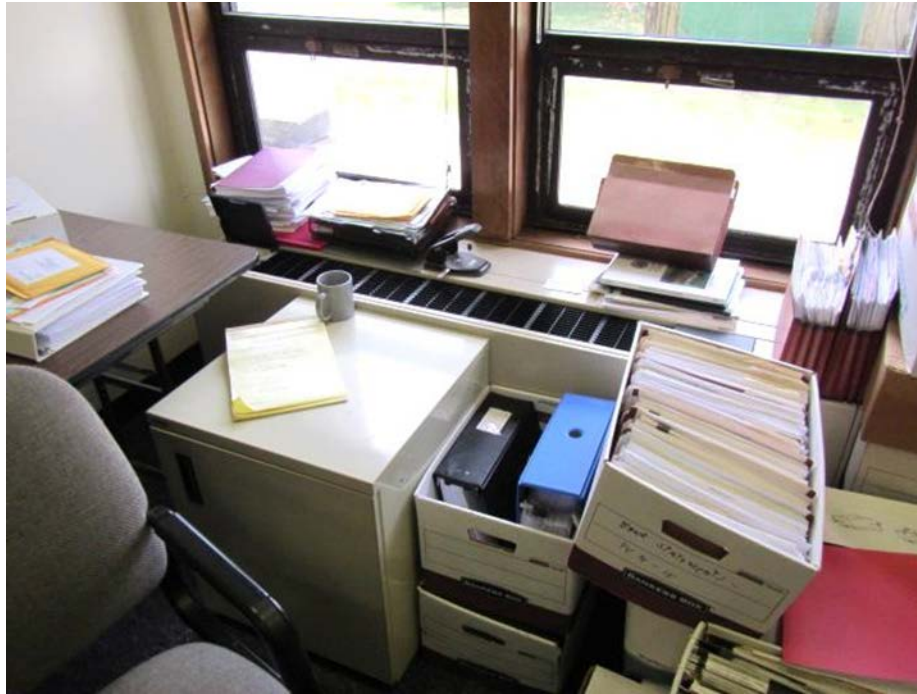
Picture 3

Items on/in front of FCU

1. Remove obstructions from in front of/on top of FCUs for proper operation.
2. Continue to change FCU filters 2 to 4 times per year, preferably using MERV 8 filters, which are adequate to filter out pollen and mold spores (ASHRAE, 2012).

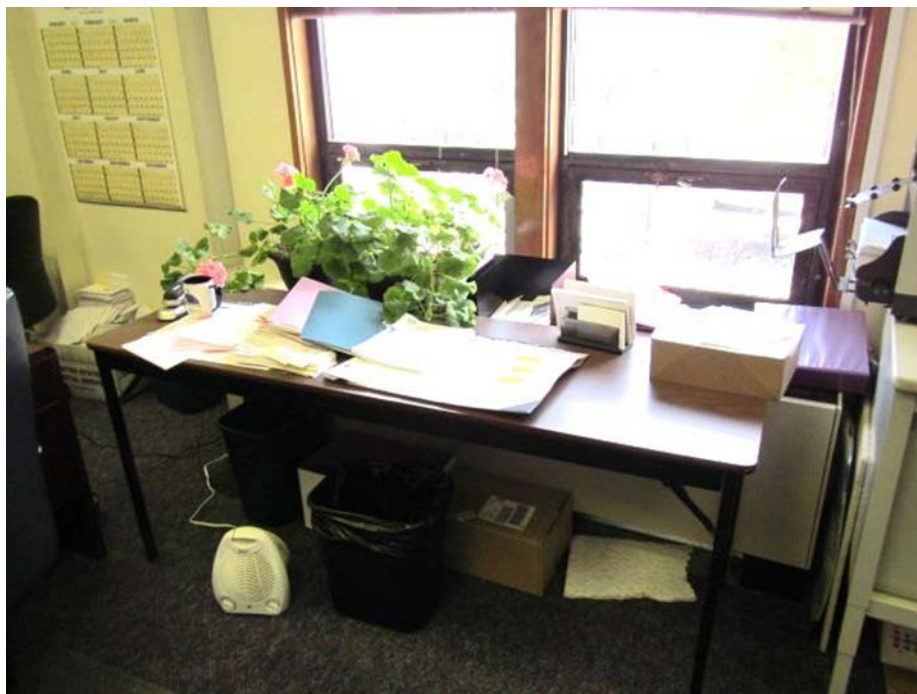
Picture 4

Plants were observed in a few areas, including on top of FCUs (Picture 4; Table 1). Plants can be a source of pollen and mold, which can be respiratory irritants to some individuals. Plants should be properly maintained and equipped with drip pans and should be located away from air diffusers to prevent the aerosolization of dirt, pollen, and mold.

Items on/front of FCU, note plant

7. Keep plants in good condition, avoid overwatering, and remove from the airstream of heating and ventilation equipment.
8. Consider reducing the amount of stored materials to allow for more thorough cleaning. Clean items regularly with a wet cloth or sponge to prevent excessive dust build-up.

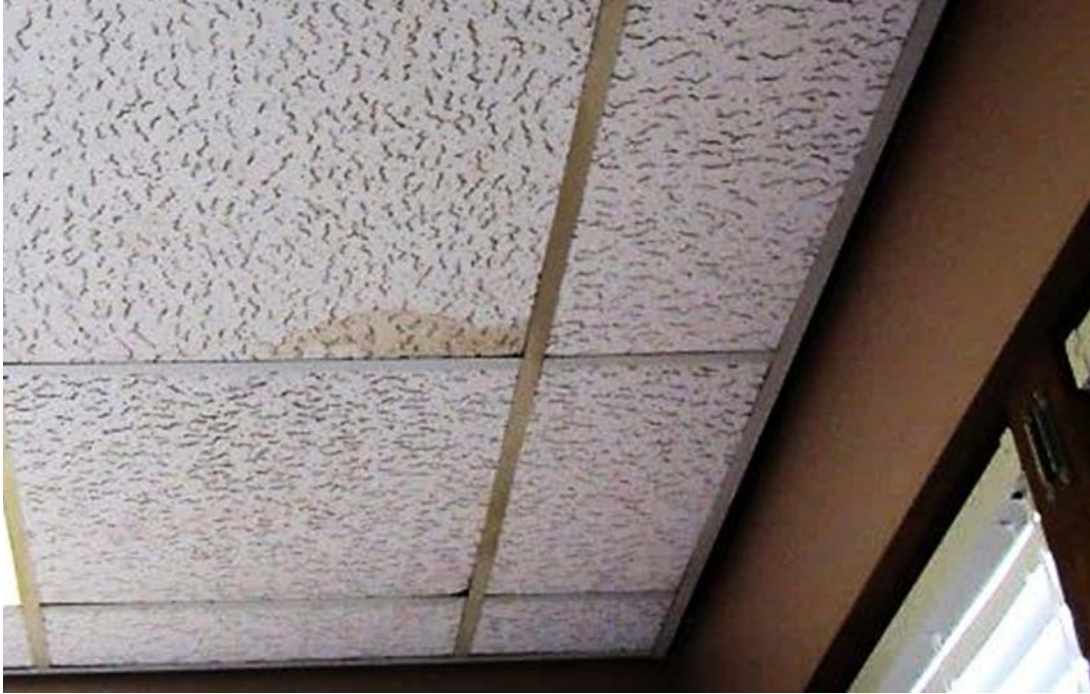
Picture 5

In order for building materials to support mold growth, a source of water exposure is necessary. Water-damaged ceiling tiles were seen in several areas (Table 1; Pictures 5 and 6). Water-damaged ceiling tiles indicate leaks from either the roof or plumbing system and can provide a source for mold growth. These tiles should be replaced after a water leak is discovered and repaired. It was reported that the damaged tiles in the Clerk's office were from a heating

Water-damaged tile in Treasure's office

3. Have the HVAC system re-balanced, as recommended (every 5 years) in accordance with SMACNA recommendations (SMACNA, 1994).
4. Ensure leaks are repaired and replace water-damaged ceiling tiles.

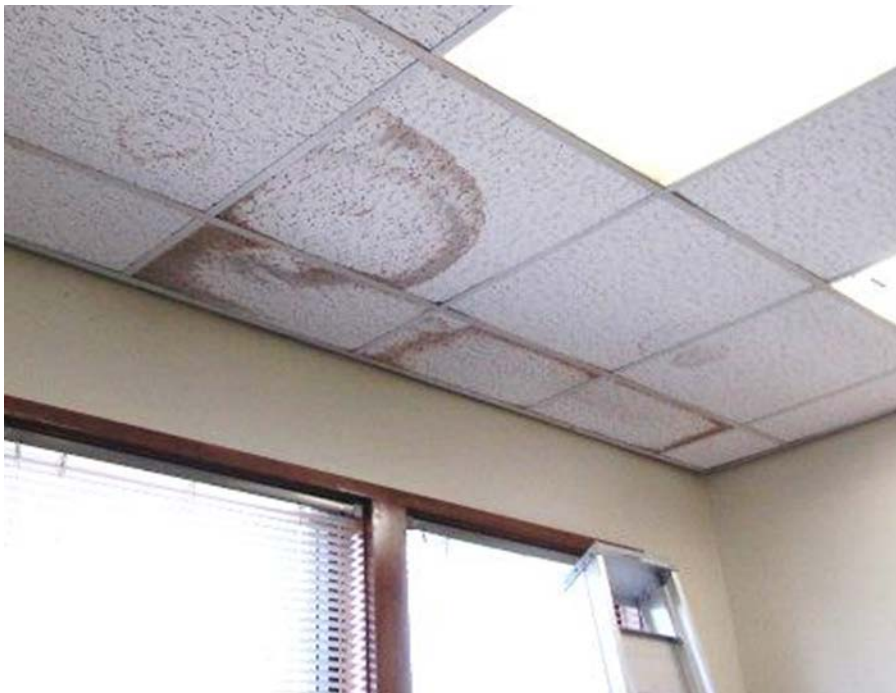
Picture 6

Water-damaged ceiling tiles in Clerk's office

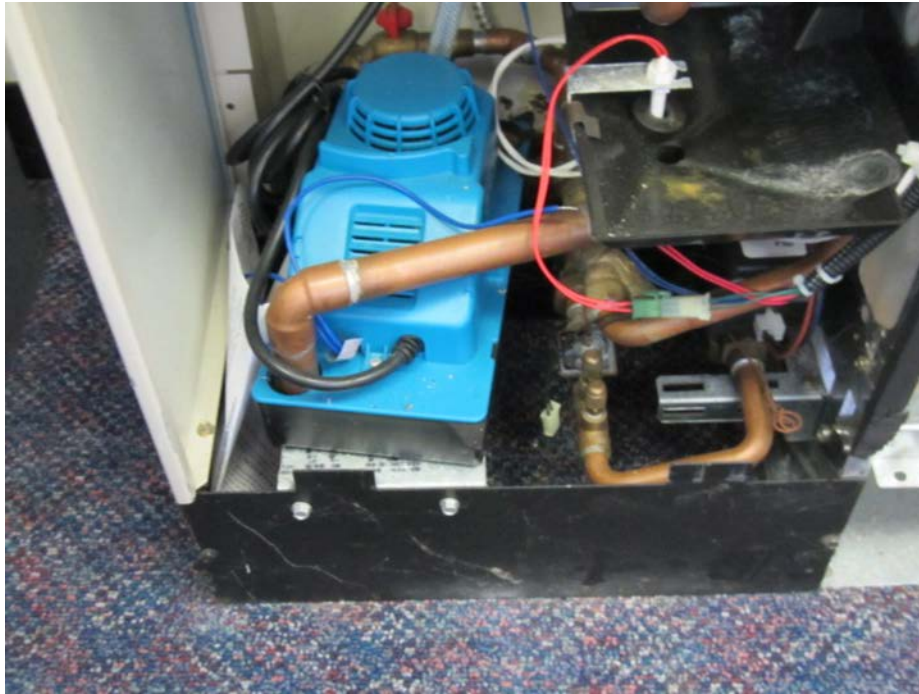
Picture 7

The space contains wall to wall carpeting. It appears that the FCUs were installed at a later date over the carpeting, which could create musty odors/mold growth conditions if components from the cooling system (i.e., uninsulated pipes, condensate pumps) leak or drip condensation (Picture 7).

FCU cooling system components directly over carpeting

5. Consider removing carpeting from beneath FCUs.
6. For buildings in New England, periods of low relative humidity during the winter are often unavoidable. Therefore, scrupulous cleaning practices should be adopted to minimize common indoor air contaminants whose irritant effects can be enhanced when the relative humidity is low. To control for dusts, a high efficiency particulate arrestance (HEPA) filter-equipped vacuum cleaner in conjunction with wet wiping of all surfaces is recommended. Avoid the use of feather dusters. Drinking water during the day can help ease some symptoms associated with a dry environment (throat and sinus irritation).

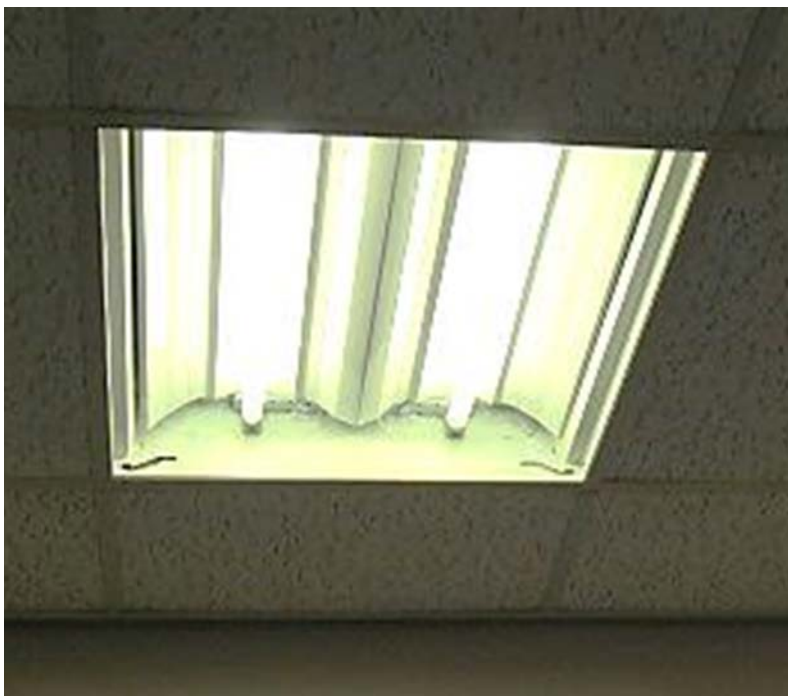
Picture 8

Finally, several areas were missing light covers (Table 1; Picture 8). Modern fluorescent bulbs contain mercury, which can be released if they are accidentally broken.

Missing light cover

11. Replace missing light covers.
12. Consider creating a log book for staff to submit specific cleaning/maintenance requests. Make log book available for staff/management in a central location. Cleaning/Maintenance requests should include date, requester, a detailed description of where and what the issue is as well as a section for cleaning/maintenance personnel to sign off or document progress of request.
